**36C SERIES 1/2-1"**  
**PRESSURE REDUCING VALVE**  
**WITH INTEGRAL BY-PASS FEATURE**

**Industries, Inc.**

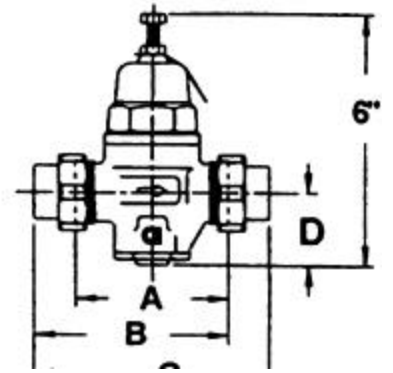
Prior to installing the 36C series Conbraco Pressure Reducing Valve, all debris should be flushed from the line. Isolate the section where the PRV is to be installed by closing the appropriate shut-off valves. Refer to Table 1 below for length dimensions for the size and end configuration of the PRV you plan to install. The 36C series PRV is designed to be installed in a piping system with the arrow on the valve pointing in the direction of flow.

TABLE 1 Dimensions (inches)	Non-union (npt x npt)		Inlet-union (npt, solder or		Double-union (npt x npt or solder x solder)	
	1/2" & 3/4"	1"	1/2" & 3/4"	1"	1/2" & 3/4"	1"
A	3 1/2"	3 3/4"	N/A	N/A	N/A	1/4"
B	N/A	1/4"	4 13/32"	4 3/4"	N/A	1/4"
C	N/A	1/4"	N/A	N/A	5 3/8"	5 7/8"
D	1 5/8"	1 1/2"	1 5/8"	1 1/2"	1 5/8"	1 1/2"

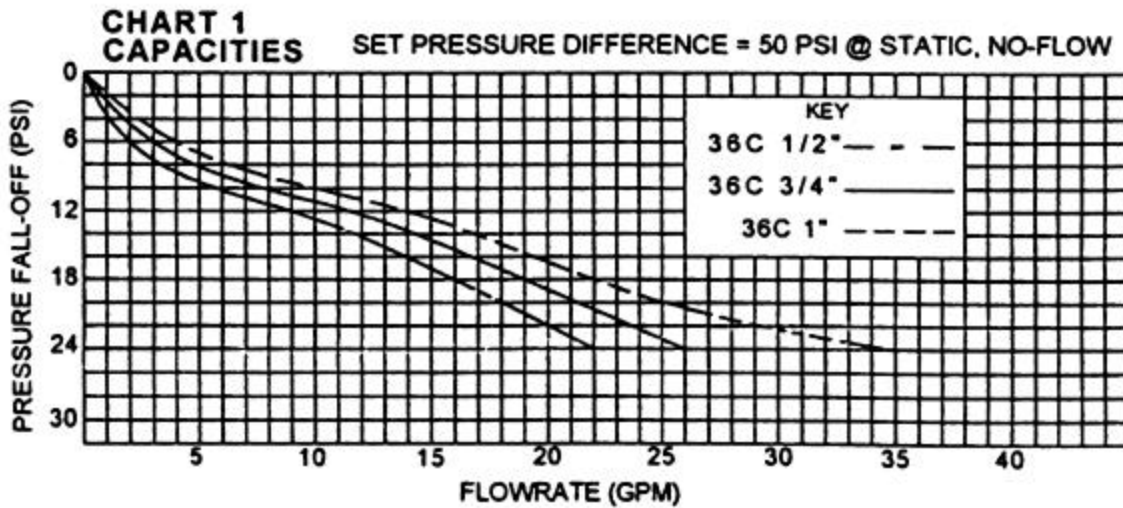
The 36C series PRV is designed to reduce pressures up to 400 psi to a more functional level within its adjustment range. The standard 36C series PRV is factory set at 50 psi outlet pressure and is adjustable from 25 to 75 psi. \*To increase the set pressure, loosen the locknut and turn the adjustment screw clockwise. To decrease the set pressure, turn the adjusting screw counter-clockwise. Re-tighten the locknut. Allow for some fall-off from the set pressure during flow conditions. Refer to Chart 1 below to determine the amount of pressure fall-off to expect at a certain rate of flow.

**Example:** A 36C 3/4" PRV has an inlet pressure of 100 psi and a set outlet pressure of 50 psi in the static, no-flow condition. The flow demand through the valve is expected to be 19 gpm. The chart shows the pressure fall-off to be about 18 psi. Thus the pressure will drop from 50 psi to approximately 32 psi at that flowrate.

**NOTE:** Although this chart shows curves at a 50 psi set differential, curves for other settings are similar. The curve shifts slightly to the left for a smaller differential and to the right for a greater differential. The adjustment is as follows: for a 25 psi set differential subtract 15% from the flowrate shown. For a 75 psi set differential add 15% to the flowrate shown.

C. Clogged strainer in the PRV. Remove clean-out plug and rinse strainer.
3. Excessive noise within the pipeline at the PRV.	High water velocities can sometimes cause a whistling or hum. A slight adjustment of the PRV may eliminate the noise. If not, the line size may be too small for the flow rate. See Chart 1 for capacities of the different PRV sizes.

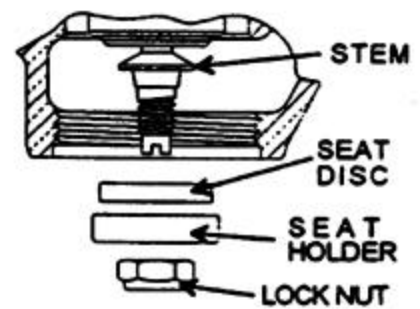
**FIG. 2**

A major repair kit is also available (36C-004-01) to replace the cartridge assembly and the two clean-out plug o-rings. Normally, the cartridge assembly does not require servicing but can become damaged due to freeze-up or overpressurizing. In this case the cap assembly and the clean-out plug will have to be removed.

Unscrew the cap assembly by placing a wrench on the 1 3/4" hex and turn counter-clockwise. With the cap off, use a finger from the bottom to push the cartridge assembly out through the top. Reverse the previous procedure when re-assembling. Be certain that the o-rings are lubricated with a non-toxic lubricant and free of foreign particles. Do not overtighten the cap assembly. Turn the adjusting screw to re-establish the pressure setting. Use a gauge to check the pressure in the downstream line. Flow a small amount of water and double-check the setting. Tighten the lock-nut.

The 36C series PRV is designed so that it can be serviced through the clean-out plug without removing the cap assembly and disturbing the pressure setting. Routine servicing usually requires that the strainer be cleaned to remove debris that can become caught on the strainer. Over time a clogged strainer can severely limit flow resulting in a high pressure loss across the device. Less frequently, the rubber seat disc may need to be replaced as they sometimes become embedded with grit or other foreign particles. Both the strainer and seat disc can be accessed from the clean-out plug (see figure 2). The plug uses a 1 1/2" hex drive. A clean-out repair kit (36C-003-01) is available that includes the seat disc, locknut, and two plug o-rings. Removing the lock-nut requires a standard screw driver to hold the stem from rotating while turning the nut with a 7/16" wrench. Assemble in the reverse order. Tighten the lock-nut firmly.
